This year started with tremendous problems! If we are calling SK7MW at 70cm and getting no answer, than must be something wrong with our station! This happened during the NAC in December.

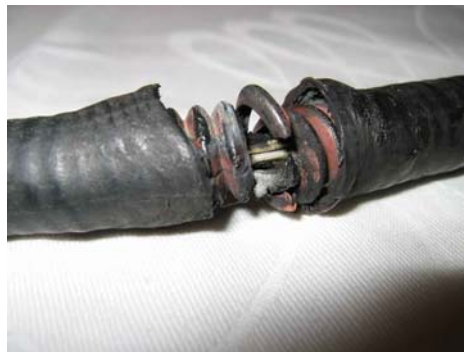
As the weather was not so fine in the last month, I had to wait for a good moment to climb up the tower and see what happened. There I could realize that we got two problems. First and most important one was an interruption at the flexible 3/8 inch coax cable between the main 7/8 inch TX- line and the coax relay which is responsible to bypass the rotator. Below You can see what happened!

In the meantime I was able to replace it.

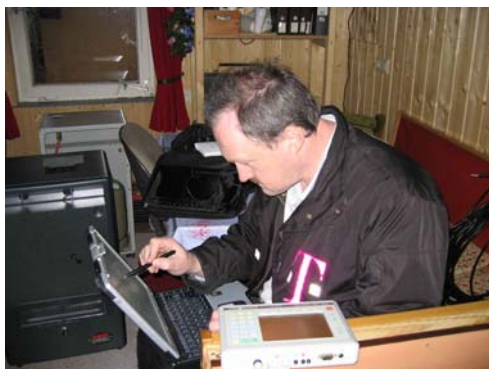
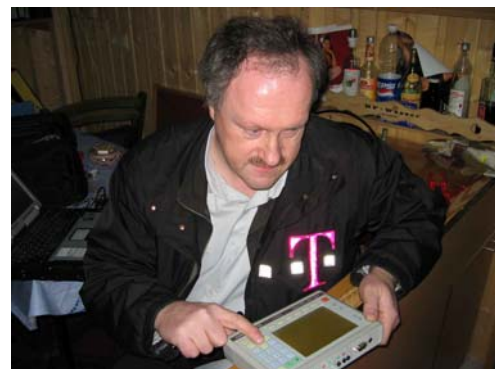
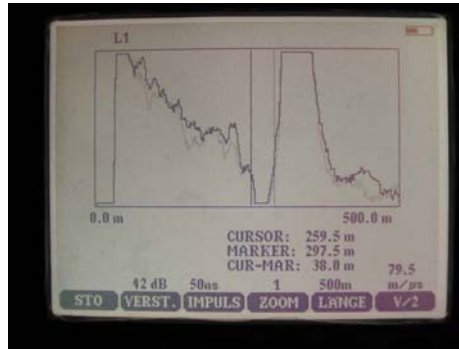
Next day I made first checks with a pulse- reflection analyser which I have in my job. As it is brand new equipment, especially for checking DSL- lines I had to learn how to use it!

The result was that the length of the cable is abt 297.5m (interruption, as we disconnected the cable), the fault (loss of isolation) is abt 38m away from the far-, or 259.5m from the near end.

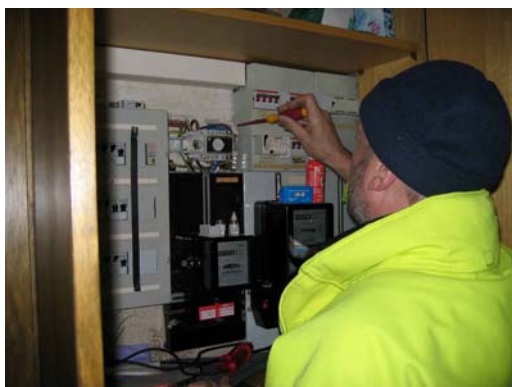
Harry prepares the line

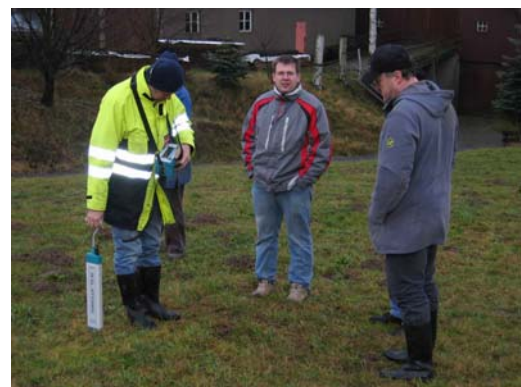
Searching the exact position of the cable with a cable- finder

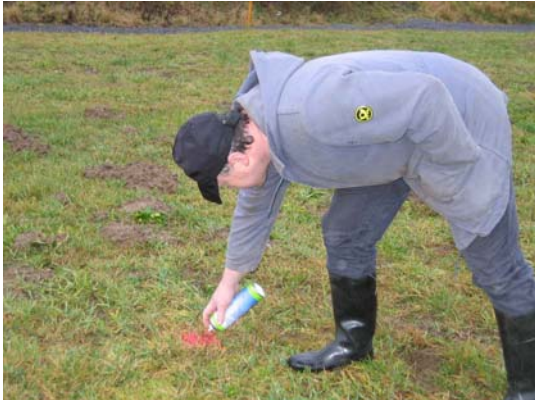
....and marking it

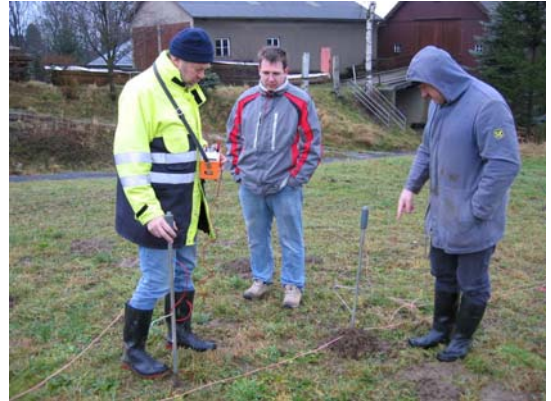
Giving HV- impulses at the line, the difference between two points can be measured!

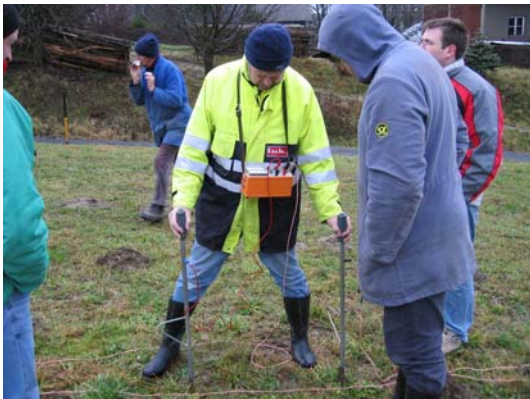
Reducing the space between the checkpoints the mistake can be localized with accuracy less than ca 2cm!!

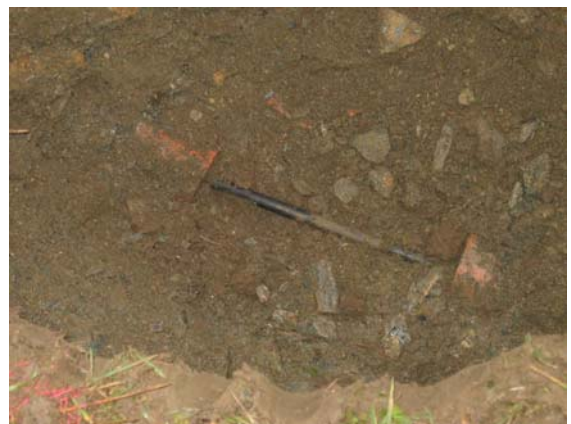
Bingo! 100% success!

After repairing the cable we are QRV again
